Case Studies ~ Pontcysyllte Aqueduct, Llangollen Canal

Exceptional heritage asset value

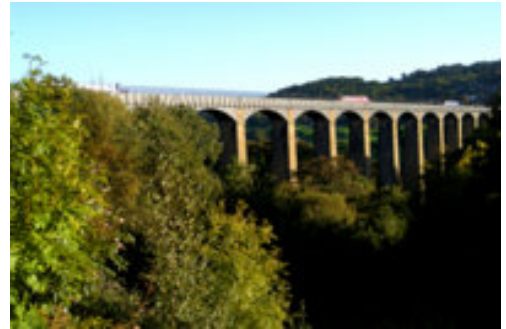
'The Pontcysyllte Aqueduct is a highly innovative monumental civil engineering structure, made using metal arches supported by high, slender masonry piers. It is the first great masterpiece of the civil engineer Thomas Telford and formed the basis of his outstanding international reputation. It bears witness to the production capacities of the British ironmaking industry, which were unique at that time.'

The authenticity and integrity of the surviving structure was a major factor in achieving these listings. Built between 1795 and 1805, the canal is carried 126 feet above the River Dee in the original cast iron trough.

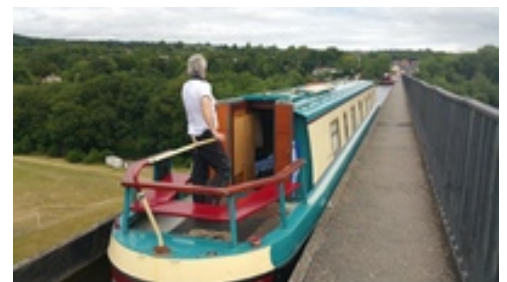
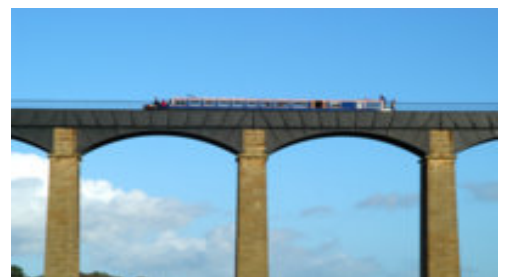
On one side there is no parapet, creating a real sense of drama for passengers crossing on board boats.

The opposite side carries the old towing path, allowing people to freely walk across the aqueduct. The iron railings that form the parapet on the towing path side offer protection from the drop. They are, however, more widely spaced than would be permitted in a new structure.

In consequence, there is an identified risk of young children squeezing between the railings. However, as the structure is of exceptional heritage asset value there is a presumption against the introduction of physical risk controls that would adversely impact on the authenticity and integrity of the original design.

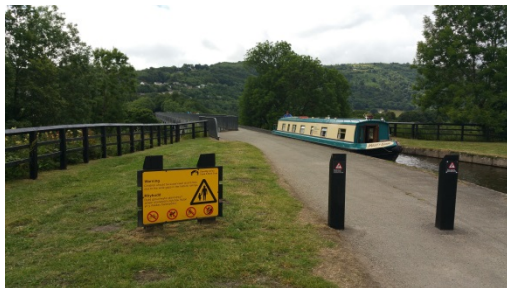
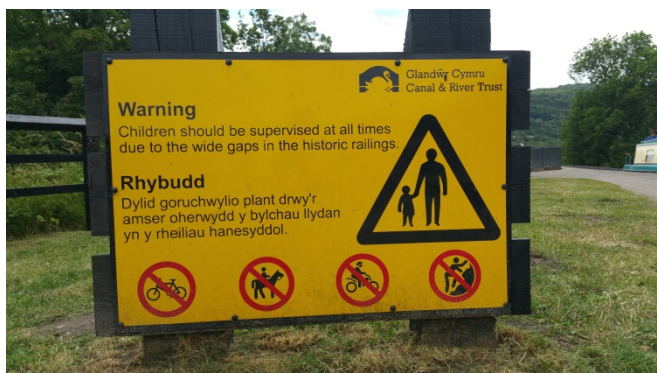
Prominent signs and posts use pictograms to convey clear advice to walkers before they reach the aqueduct.
